**Flood Control Project Maintenance
Levee Inspections**
LMA District Cover Sheet
Spring 2018 Levee Inspection Results

Madera County FCWCA

**Flood Control Project Maintenance
Levee Inspections
Unit Cover Sheet
Spring 2018 Levee Inspection Results
Madera County FCWCA**

Waterway			Bank	Unit Miles
Unit No. 01 Ash Slough			Right	2.37
	Spring (March - May)	Summer (June - August)	(September - November) Fall	Winter (December - February)
Unit Maintenance Rating (Fall Only)				
Date of Inspection	4/17/2018 - 4/17/2018			
DWR Inspector	Richard Willoughby			
Accompanied By

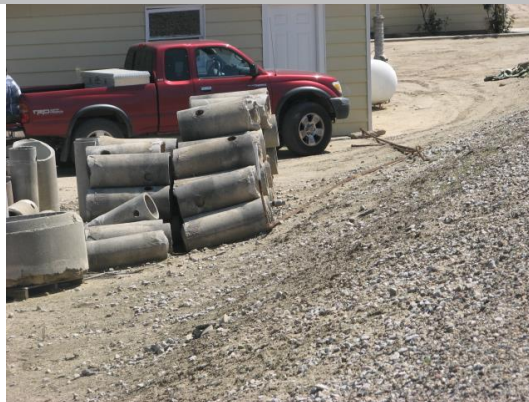
Photo 1 of 1 : SP_2018_NA0011_146_26_20180411_00022.jpg

LM Start	8.53	Rating **	M	Issue No.	26
LM End	8.53	Issue Type +	En	Location *	LS
Category	Earthen Levee			GPS Latitude/Longitude	
				Start	End
Item	Encroachments			36.972616 °	36.972606 °
				-120.221415 °	-120.221389 °
DWR ID	DWR_NA0011_05_f_2017_26				
Comment Code					
EQ : Equipment					
Inspector Comment					
Concrete pipes at landward toe.

Looking upstream at concrete pipes stored at landward toe. (Spring 2018)

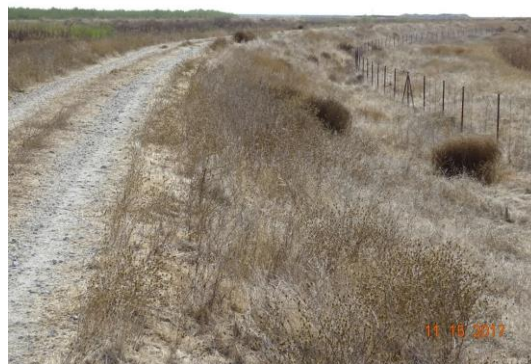
Photo 1 of 1 : SP_2018_NA0011_147_15_20180307_00004.jpg

LM Start	0.01	Rating **	M	Issue No.	15
LM End	0.99	Issue Type +	Ma	Location *	LS
Category	Earthen Levee			GPS Latitude/Longitude	
				Start	End
Item	Vegetation			36.976937 °	36.968862 °
				-120.367310 °	-120.354232 °
DWR ID	DWR_NA0011_06_f_2017_15				
Comment Code					
V1 : Control annual grass and weeds on the levee slopes and easements.					
Inspector Comment

Landside vegetation should be managed to allow inspection and access.

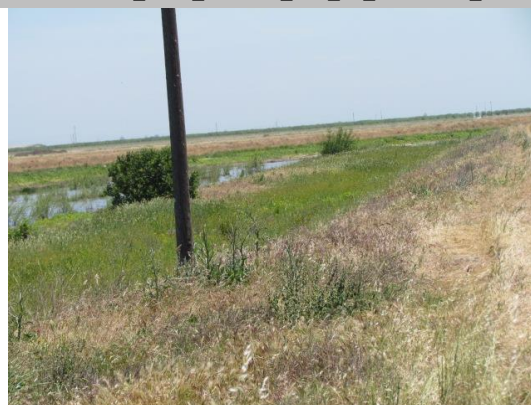
Photo 1 of 1 : SP_2018_NA0011_147_11_20180307_00002.jpg

LM Start	0.01	Rating **	M	Issue No.	11
LM End	2.48	Issue Type +	Ma	Location *	WS
Category	Earthen Levee			GPS Latitude/Longitude	
				Start	End
Item	Vegetation			36.976937 °	36.967257 °
				-120.367308 °	-120.328151 °
DWR ID	DWR_NA0011_06_f_2016_11				
Comment Code					
V1 : Control annual grass and weeds on the levee slopes and easements.					
Inspector Comment					
Remove the unwanted tall weed growth from the waterside slope and shoulder.

Fresno River levee mile 0.01 looking upstream wild weed growth present on the slope and shoulder.

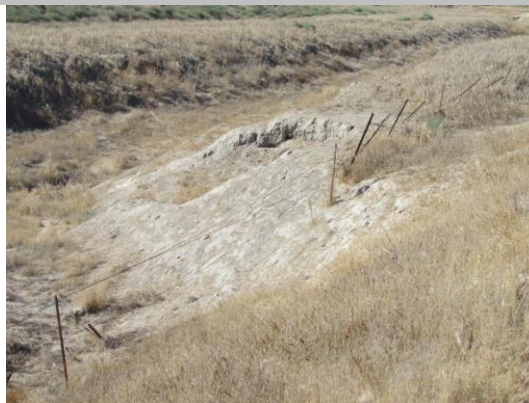
Photo 1 of 1 : SP_2018_NA0011_147_20_20180307_00007.jpg

LM Start	0.44	Rating **	U	Issue No.	20
LM End	0.44	Issue Type +	Ma	Location *	LS
Category	Earthen Levee			GPS Latitude/Longitude	
				Start	End
Item	Erosion / Bank Caving			36.975030 °	36.975014 °
				-120.360382 °	-120.360401 °
DWR ID	DWR_NA0011_06_f_2012_20				
Comment Code					
E2 : Schedule repair of erosion site prior to the next inspection.					
Inspector Comment					
This erosion should be taken care of before it gets worse. During the spring inspection on 4-24-2014 the erosion couldn't be seen as the area was overtaken with weeds.

Looking downstream at the old erosion site landside slope.

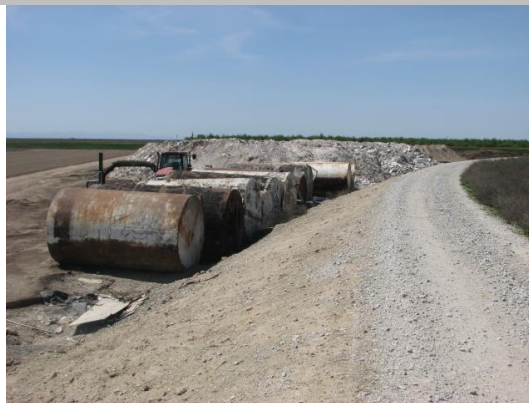
Photo 1 of 2 : SP_2018_NA0011_147_1_20180411_00039.jpg

LM Start	1.08	Rating **	U	Issue No.	1
LM End	1.14	Issue Type +	En	Location *	LS
Category	Earthen Levee			GPS Latitude/Longitude	
				Start	End
Item	Encroachments			36.967781 °	36.967395 °
				-120.353321 °	-120.352362 °
DWR ID	DWR_NA0011_06_s_2012_1				
Comment Code					
DE : Debris					
Inspector Comment					
Large piles of broken up recycled sheet rock placed within 10-foot of the levee easement.

Looking upstream at tanks and sheet rock piles at landward toe. (Spring 2018)

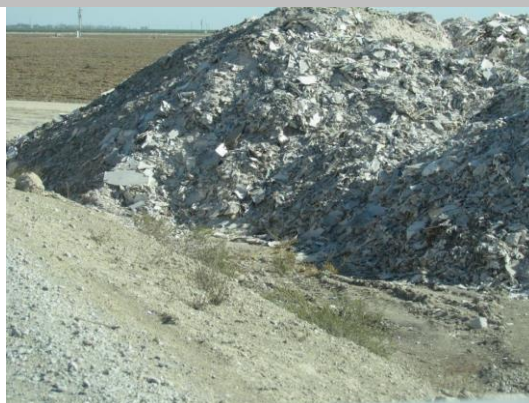
Photo 2 of 2 : SP_2018_NA0011_147_1_20180307_00001.jpg

Recycle sheet rock piles within the landside easement.

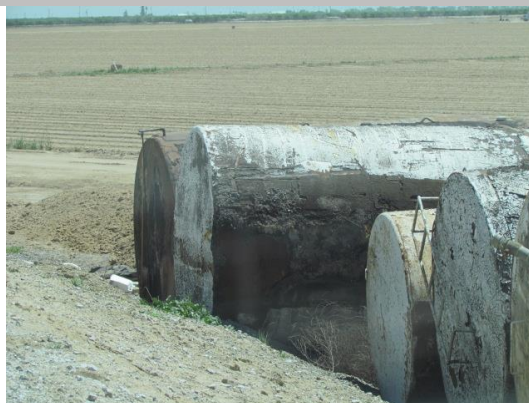
Photo 1 of 1 : SP_2018_NA0011_147_39_20180307_00016.jpg

LM Start	1.14	Rating **	U	Issue No.	39
LM End	1.17	Issue Type +	En	Location *	LS
Category	Earthen Levee			GPS Latitude/Longitude	
				Start	End
Item	Encroachments			36.967387 °	36.967270 °
				-120.352340 °	-120.351902 °
DWR ID	DWR_NA0011_06_s_2014_39				
Comment Code					
TA : Tank					
Inspector Comment					
Metal storage tanks are within the easement of the landward toe. Move them away from the easement.

Fresno River landside levee mile 1.16.

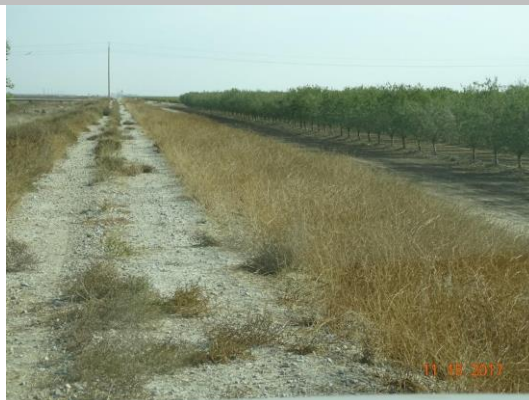
Photo 1 of 1 : SP_2018_NA0011_147_21_20180307_00008.jpg

LM Start	1.98	Rating **	M	Issue No.	21
LM End	2.48	Issue Type +	Ma	Location *	LS
Category	Earthen Levee			GPS Latitude/Longitude	
				Start	End
Item	Vegetation			36.967221 °	36.967252 °
				-120.337208 °	-120.328226 °
DWR ID	DWR_NA0011_06_f_2017_21				
Comment Code					
V1 : Control annual grass and weeds on the levee slopes and easements.					
Inspector Comment

Landside vegetation should be managed to allow inspection and access to slope and toe.

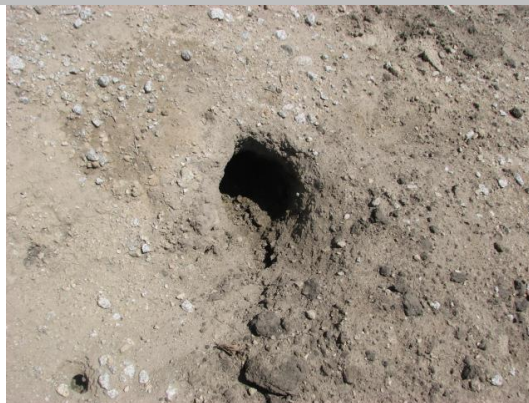
Photo 1 of 1 : SP_2018_NA0011_147_53_20180411_00040.jpg

LM Start	5.44	Rating **	U	Issue No.	53
LM End	5.44	Issue Type +	Ma	Location *	LS
Category	Earthen Levee			GPS Latitude/Longitude	
				Start	End
Item	Animal Control			36.967514 °	36.967514 °
				-120.274810 °	-120.274810 °
DWR ID	DWR_NA0011_06_s_2018_53				
Comment Code					
A3 : No rodents visible, but rodent burrows visible; need to backfill and compact or grout burrows.					
Inspector Comment					
Control rodents within this section.

Looking at typical rodent hole on landward slope. (Spring 2018)

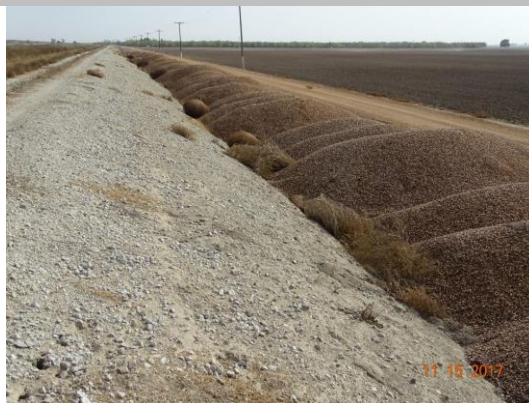
Photo 1 of 1 : SP_2018_NA0011_147_35_20180307_00013.jpg

LM Start	5.50	Rating **	A/W	Issue No.	35
LM End	5.67	Issue Type +	En	Location *	LS
Category	Earthen Levee			GPS Latitude/Longitude	
				Start	End
Item	Encroachments			36.967509 °	36.967505 °
				-120.273672 °	-120.270605 °
DWR ID	DWR_NA0011_06_f_2017_35				
Comment Code					
DE : Debris					
Inspector Comment					
Remove pistachio/hull piles from levee toe.

Piles of pistachio hulls obstruct inspection and access. Should be removed.

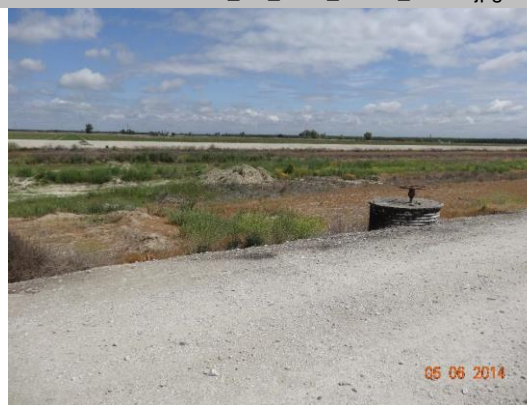
Photo 1 of 3 : UCIP_SP_2018_39008_64570.jpg

LM Start	6.17	Rating **	M	Issue No.	54
LM End	6.17	Issue Type +	En	Location *	
Category	Supplemental			GPS Latitude/Longitude	
				Start	End
Item	DWR UCIP Field Study			36.967568 °	36.967568 °
				-120.261594 °	-120.261594 °
DWR ID					
Comment Code					
Inspector Comment					
FS_ID:39008 DS_ID:21531 EP_NO: N/A Repair Type: Non-Urgent Crossing Status: Found UCIP Comments: Need to contact owner. Recommend removing sediment built up on landward side. FIELD_STRUCT_DESC: 48-inch corrugated metal gravity drainage pipe through the levee, 11.5 feet below the crown. Slide gate on the waterside (WS) shoulder. Headwall and wing wall on each end. Flap gate on the WS end. [Additional Reference(s): DWR Levee Log, 2005]. FS Date: 5/6/2014

View of waterward side.

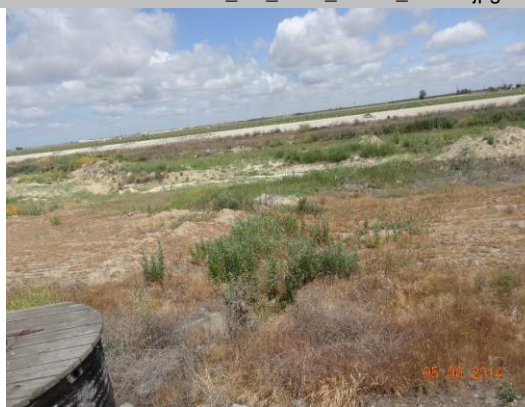
Photo 3 of 3 : UCIP_SP_2018_39008_64572.jpg

Overview of channel at crossing.

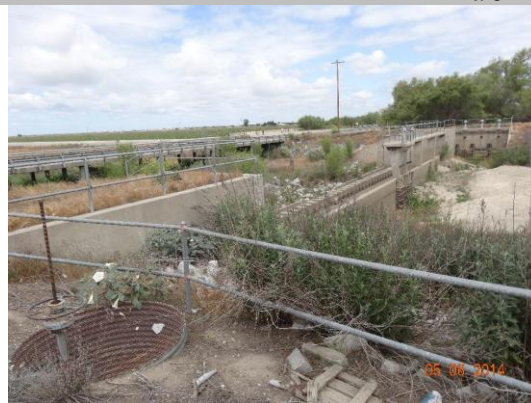
Photo 1 of 3 : UCIP_SP_2018_49980_69722.jpg

Comment Code					
Inspector Comment					
FS_ID:49980 DS_ID:21532 EP_NO: N/A Repair Type: Non-Urgent Crossing Status: Found UCIP Comments: 7/14/2016 Same as previous inspection. Need to coordinate with owner. Need permit number authorizing work. (DWR UCIP - omagana)5/06/2014 Need to contact owner. Crossing on landward side appears to be modified--no headwall found on landward end. (DWR UCIP - omagana) FIELD_STRUCT_DESC: 30-inch corrugated metal pipe (CMP) of an unknown purpose through the levee, 12 feet below the crown. Slide gate in a 5-foot CMP riser on the waterside (WS) shoulder. Headwall and wing wall on the WS end. Concrete headwall on the landside (LS) end. [Additional Reference(s): DWR Levee Log, 2005]. FS Date: 7/14/2016

View of WS.

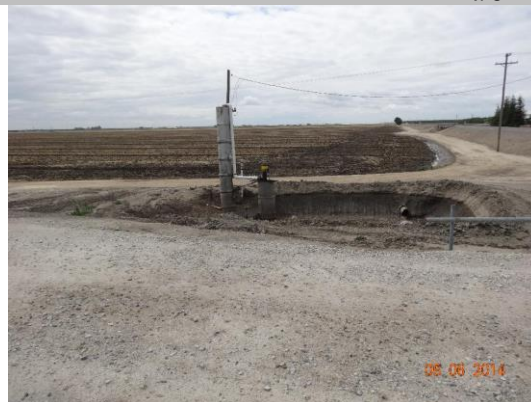
Photo 2 of 3 : UCIP_SP_2018_49980_69724.jpg

View of LS.

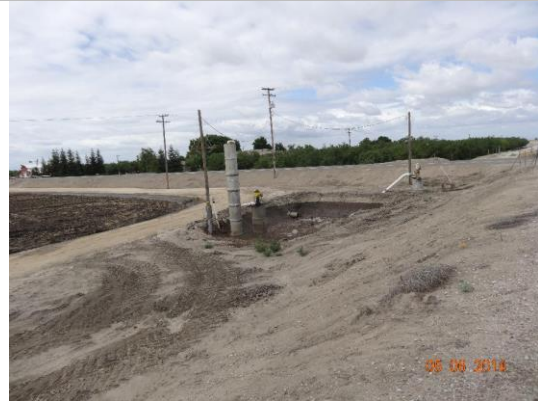
Photo 3 of 3 : UCIP_SP_2018_49980_69723.jpg

Comment Code						
Inspector Comment						
FS_ID:49980						
DS_ID:21532						
EP_NO: N/A						
Repair Type: Non-Urgent						
Crossing Status: Found						
UCIP Comments: 7/14/2016 Same as previous inspection. Need to coordinate with owner. Need permit number authorizing work. (DWR UCIP - omagana)5/06/2014 Need to contact owner. Crossing on landward side appears to be modified--no headwall found on landward end. (DWR UCIP - omagana)						
FIELD_STRUCT_DESC: 30-inch corrugated metal pipe (CMP) of an unknown purpose through the levee, 12 feet below the crown. Slide gate in a 5-foot CMP riser on the waterside (WS) shoulder. Headwall and wing wall on the WS end. Concrete headwall on the landside (LS) end. [Additional Reference(s): DWR Levee Log, 2005].						
FS Date: 7/14/2016

Additional structures found on LS.

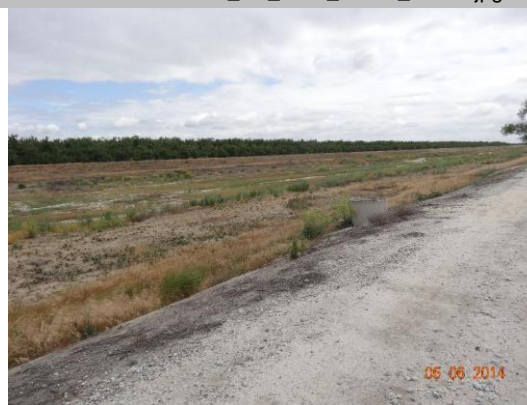
Photo 1 of 3 : UCIP_SP_2018_35804_64585.jpg

Comment Code						
Inspector Comment						
FS_ID:35804 DS_ID:21587 EP_NO: 13837 Repair Type: Non-Urgent Crossing Status: Found UCIP Comments: Need to contact owner. Dense vegetation limits the inspector's visibility to identify signs of pipe failure (leaks) along the waterward slope. Recommend removing vegetation along pipe alignment to conduct proper inspection of structure and appurtenances. FIELD_STRUCT_DESC: 12-inch reinforced concrete gravity irrigation pipe through the levee, 7.5 feet below the floodplain. The pipe extends to a 27-inch concrete standpipe in the overflow area and through the levee section to a 30-inch standpipe on the landside (LS). Positive closure device with walkway on the waterside (WS). (Plans to install a 20-inch concrete pipe through the levee for irrigation authorized under Permit No. 13837, 1984 - Averill Ranch). FS Date: 5/6/2014

View of waterward side.

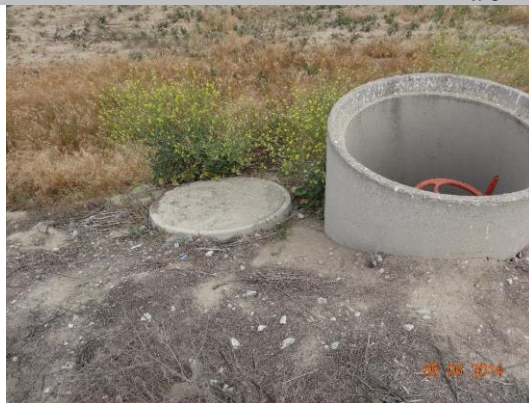
Photo 2 of 3 : UCIP_SP_2018_35804_64588.jpg

FS_ID:35804
DS_ID:21587
EP_NO: 13837
Repair Type: Non-Urgent
Crossing Status: Found
UCIP Comments: Need to contact owner. Dense vegetation limits the inspector's visibility to identify signs of pipe failure (leaks) along the waterward slope. Recommend removing vegetation along pipe alignment to conduct proper inspection of structure and appurtenances.
FIELD_STRUCT_DESC: 12-inch reinforced concrete gravity irrigation pipe through the levee, 7.5 feet below the floodplain. The pipe extends to a 27-inch concrete standpipe in the overflow area and through the levee section to a 30-inch standpipe on the landside (LS). Positive closure device with walkway on the waterside (WS). (Plans to install a 20-inch concrete pipe through the levee for irrigation authorized under Permit No. 13837, 1984 - Averill Ranch).
FS Date: 5/6/2014

View of concrete standpipe and lid found on waterward shoulder.

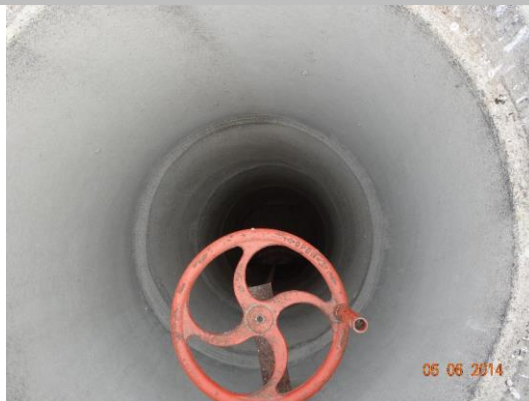
Photo 3 of 3 : UCIP_SP_2018_35804_64584.jpg

Inside view of standpipe located on waterward side.

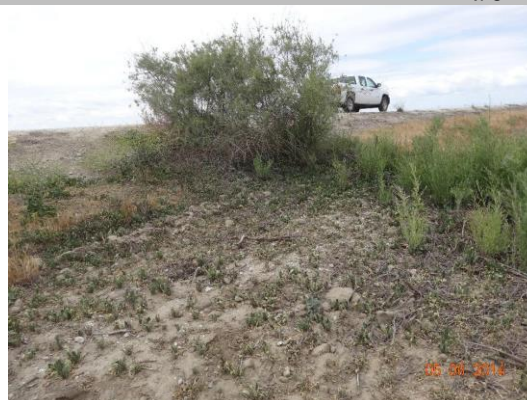
Photo 3 of 3 : UCIP_SP_2018_35805_64594.jpg

Comment Code						
Inspector Comment						
FS_ID:35805						
DS_ID:21588						
EP_NO: 13856						
Repair Type: Non-Urgent						
Crossing Status: Found						
UCIP Comments: Need to contact owner. Dense vegetation limits the inspector's visibility to identify signs of pipe failure (leaks) along the waterward slope. Recommend removing vegetation along pipe alignment to conduct proper inspection of structure and appurtenances.						
FIELD_STRUCT_DESC: 12-inch reinforced concrete gravity irrigation pipe through the levee, approximately 4 feet below the crown. The pipe extends from a 24-inch standpipe in the overflow area and through the levee section to a 36-inch standpipe on the landside (LS). Positive closure device with a walkway on the waterside (WS). (Plans to install a 20-inch concrete gravity irrigation pipe through the levee authorized under Permit No. 13856, 1984 - Averill Ranch).						
FS Date: 5/6/2014

View of waterward slope.

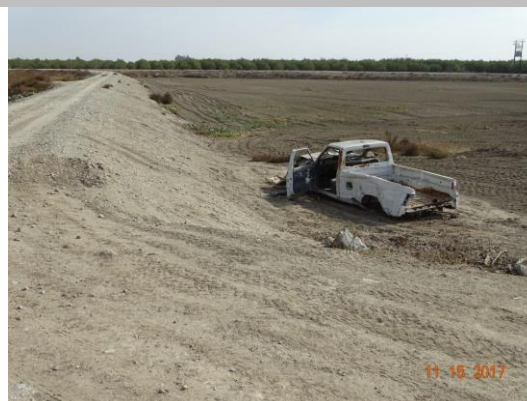
Photo 1 of 1 : SP_2018_NA0011_147_45_20180307_00017.jpg

LM Start	7.47	Rating **	U	Issue No.	45
LM End	7.47	Issue Type +	En	Location *	LS
Category	Earthen Levee			GPS Latitude/Longitude	
				Start	End
Item	Encroachments			36.968862 °	36.968862 °
				-120.238312 °	-120.238312 °
DWR ID	DWR_NA0011_06_f_2017_45				
Comment Code					
AV : Abandoned vehicles					
Inspector Comment

Abandoned vehicle obstructs inspection and access in 10-foot easement at levee toe. Should be removed from 10-foot easement.

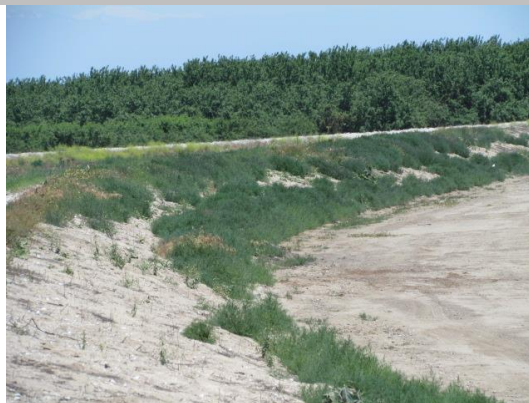
Photo 1 of 1 : SP_2018_NA0011_147_29_20180307_00010.jpg

LM Start	7.70	Rating **	M	Issue No.	29
LM End	8.52	Issue Type +	Ma	Location *	LS
Category	Earthen Levee			GPS Latitude/Longitude	
				Start	End
Item	Vegetation			36.969591 °	36.971509 °
				-120.234235 °	-120.220438 °
DWR ID	DWR_NA0011_06_s_2017_29				
Comment Code					
V2 : Remove the wild growth other than native grasses from the levee slopes.					
Inspector Comment					
Remove the wild growth from the landside slope.

Fresno River landside levee mile 7.71-8.59.

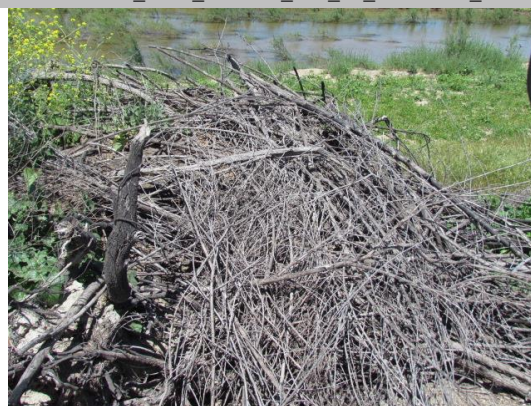
Photo 1 of 1 : SP_2018_NA0011_147_32_20180307_00012.jpg

LM Start	7.96	Rating **	M	Issue No.	32
LM End	7.96	Issue Type +	Ma	Location *	WS
Category	Earthen Levee			GPS Latitude/Longitude	
				Start	End
Item	Encroachments			36.971543 °	36.971543 °
				-120.230285 °	-120.230285 °
DWR ID	DWR_NA0011_06_s_2017_32				
Comment Code					
PR : Prunings					
Inspector Comment					
Remove the brush pile from the levee slope. This pile is providing habitat for rodents.

Fresno River waterside levee mile 7.96.

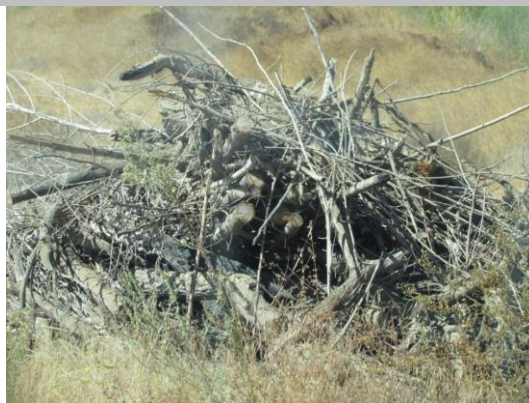
Photo 1 of 1 : SP_2018_NA0011_147_31_20180307_00011.jpg

LM Start	8.09	Rating **	U	Issue No.	31
LM End	8.09	Issue Type +	Ma	Location *	WS
Category	Earthen Levee			GPS Latitude/Longitude	
				Start	End
Item	Encroachments			36.971692 °	36.971692 °
				-120.227957 °	-120.227957 °
DWR ID	DWR_NA0011_06_f_2015_31				
Comment Code					
TR : Tree or limb					
Inspector Comment					
Remove the dead tree off the slope and shoulder, this has been reported in the last two inspections.

Fresno River levee mile 8.09.

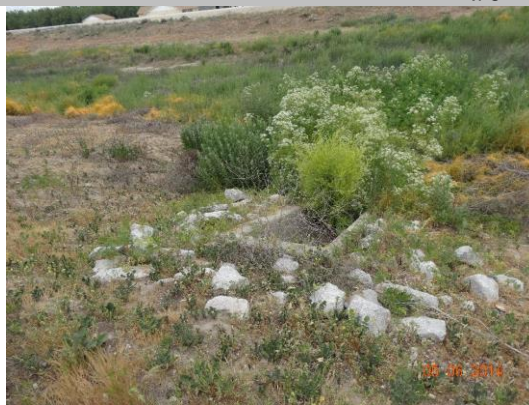
Photo 2 of 3 : UCIP_SP_2018_35806_64599.jpg

Rip rap around concrete headwall located on waterward side.

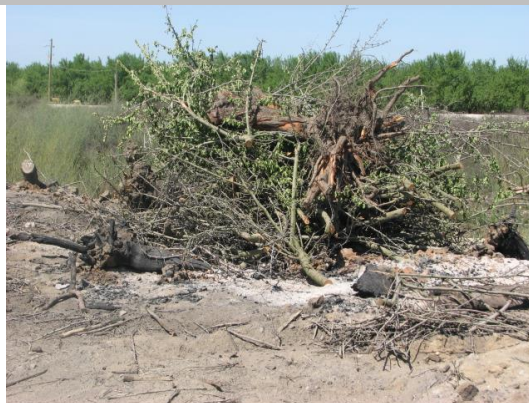
Photo 1 of 2 : SP_2018_NA0011_147_50_20180411_00043.jpg

LM Start	8.93	Rating **	U	Issue No.	50
LM End	8.93	Issue Type +	En	Location *	CR
Category	Earthen Levee			GPS Latitude/Longitude	
				Start	End
Item	Encroachments			36.972286 °	36.972286 °
				-120.213284 °	-120.213284 °
DWR ID	DWR_NA0011_06_f_2017_50				
Comment Code					
PR : Prunings					
Inspector Comment					
Remove or burn prunings pile on crown.

Looking upstream at pruning pile on waterward shoulder and crown.
(Spring 2018)

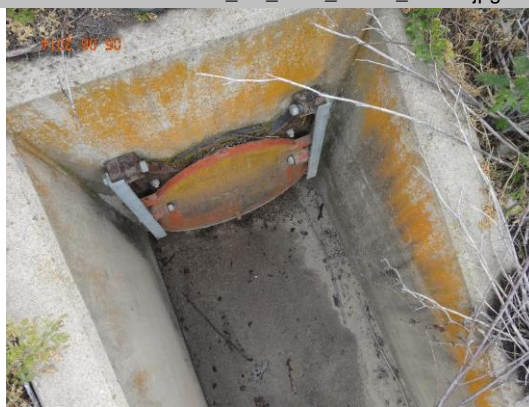
Photo 2 of 3 : UCIP_SP_2018_49981_64604.jpg

Flap gate visible on WS.

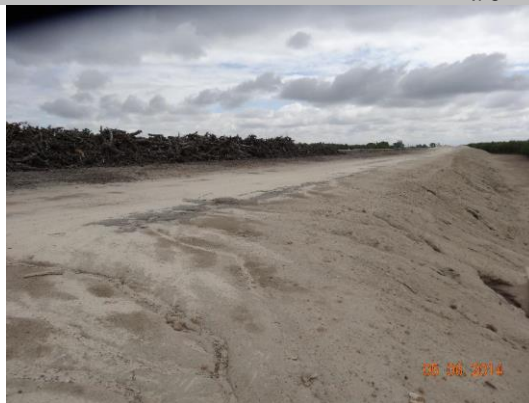
Photo 3 of 3 : UCIP_SP_2018_49981_64603.jpg

Comment Code						
Inspector Comment						
FS_ID:49981 DS_ID:21530 EP_NO: N/A Repair Type: Urgent Crossing Status: Found UCIP Comments: 7/14/2016 Surface erosion still present on LS shoulder. Unable to determine if surface erosion is due to internal pipe failure. Unable to locate concrete headwall on WS toe. Need to coordinate with owner to address erosion or potential pipe failure. Also recommend removing dense vegetation on WS. (DWR UCIP - omagana)5/06/2014 Need to contact owner. Surface erosion on landward slope unable to determine if pipe failed or if rodent activity burrow hole has caused collapse on slope. Need to determine cause for erosion. (DWR UCIP - omagana) FIELD_STRUCT_DESC: 30-inch corrugated metal gravity drainage pipe through the levee, 10.2 feet below the crown. Headwall and wing wall on each end. Flap gate on the waterside (WS) end. [Additional Reference(s): DWR Levee Log, 2005]. FS Date: 7/14/2016

View of LS.
